# Physical Facilities Assessment

St. Raphael Parish  
1215 Modaff Road  
Naperville, Illinois 60540

Healy | Bender Project No.: 8-415-81

May 4, 2016

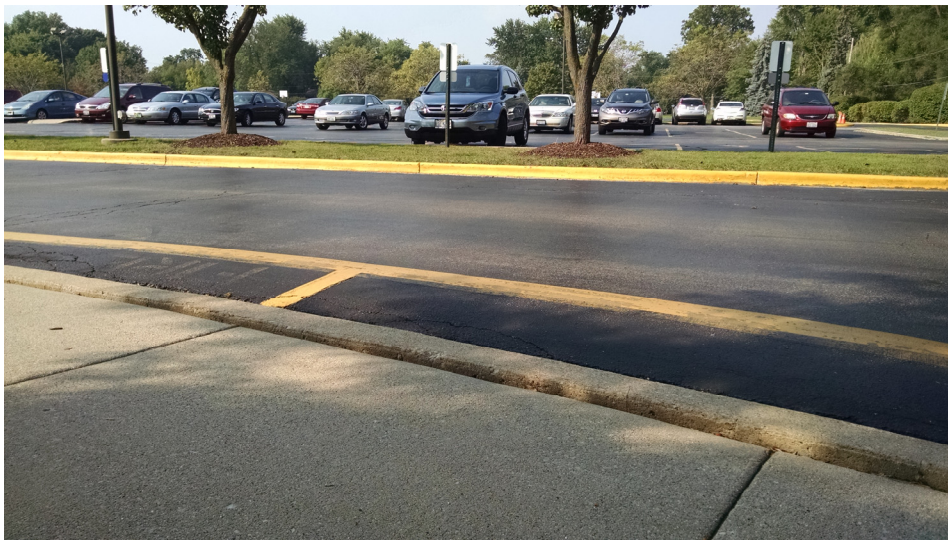
Four concrete pedestrian sidewalks connect the parish facilities to the neighborhood, all of which link to Modaff and are generally in good condition. The eastern edge of the parking lot abutting the facilities provides a continuous sidewalk of at least 5' wide providing ample room to collect pedestrians from the parking lot. The concrete walks are raised several inches providing a physical separation between vehicles and pedestrians. Entry walks to the school and parish offices are concrete, easily identifiable as entry points, and adequately situated. Sidewalks on-site are generally in good condition, though limited areas particularly near the church entry should be repaired or replaced to minimize tripping hazards where the backside of curb is not level with the walk.

**Typical concrete walk with curb**

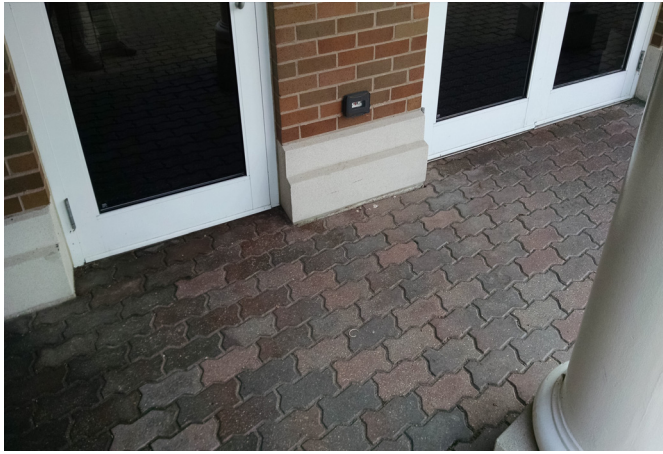
Main entry walks at the church, parish offices and school lead directly to accessible building entrances. There are several doors around the perimeter of the building where thresholds exceed ½" or where the interior floor slab is greater than ½" compared to the concrete walk, stoop or landing immediately outside. Transitions greater than ½" are not considered accessible and though not every entry is required to be fully accessible, it is recommended to proceed with improvements meeting Illinois Accessibility Standards when future site work is performed in these areas.

Exterior doors at Narthex

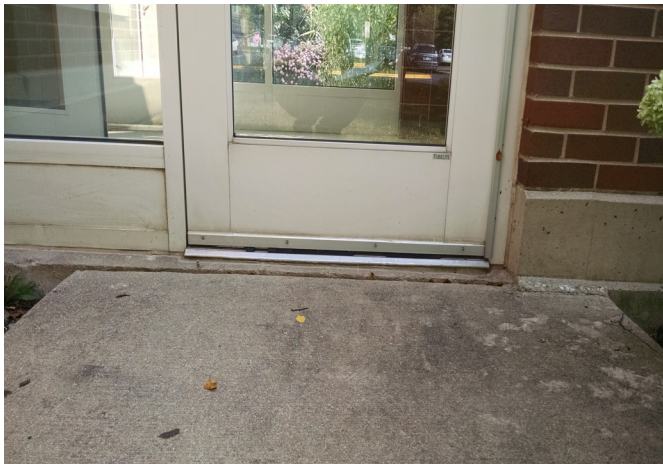
Exterior door at Church/Parish Office connection

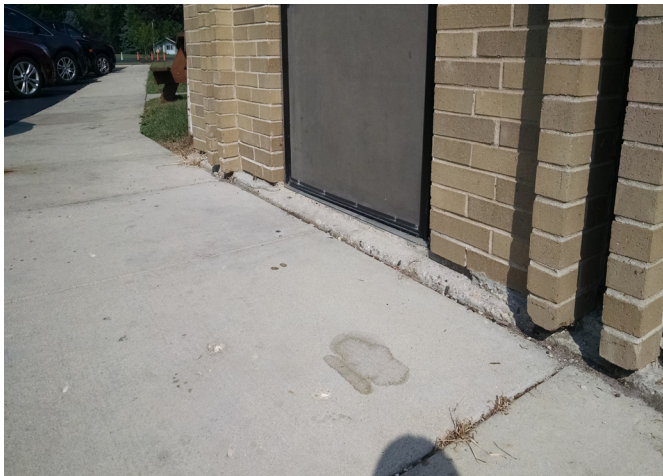
Southwest exterior door at Gymnasium

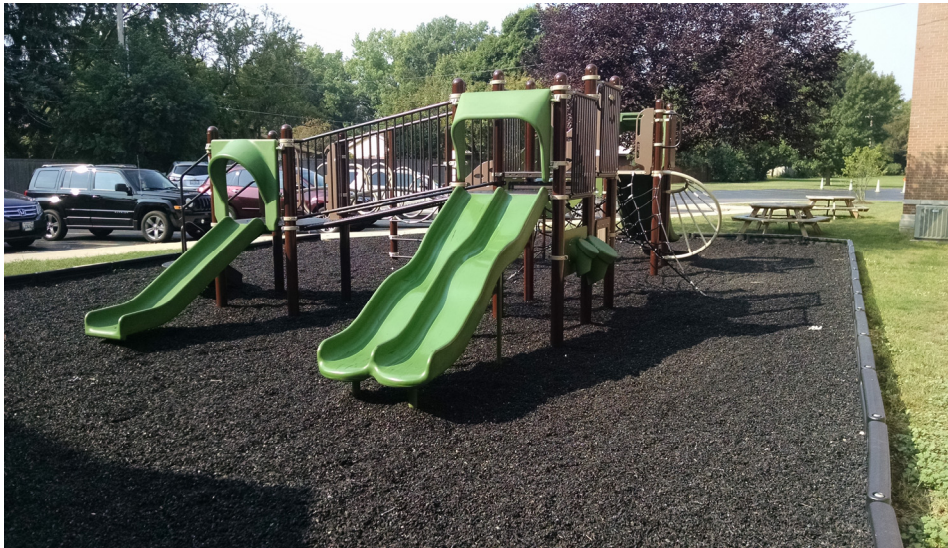
The playground perimeter curb and equipment is not compliant with accessibility standards, but the equipment appears to be less than two years old and is in 'like new' condition with no apparent maintenance concerns. The area is provided with rubber mulch.

**Playground with rubber mulch**

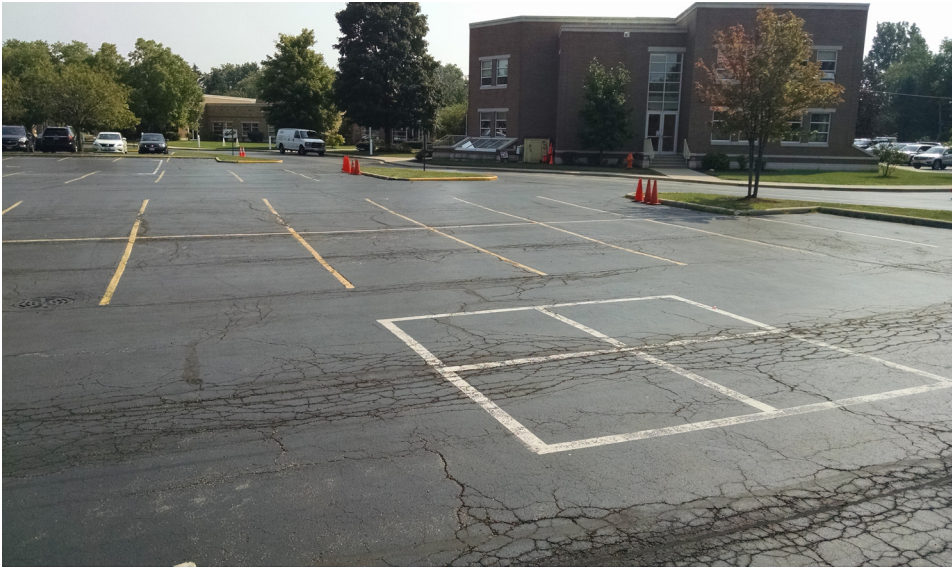
Two drives at Modaff are the only vehicular site access points and both terminate at the east end of the property. Parking and drive areas are bituminous pavement, generally in good condition with limited areas of minor or major alligating. Alligating is a condition easily recognized by a series of cracks grouped together in one area. This type of cracking is indicative of subgrade problems. The closer these cracks are together, the shallower the failure. Inversely, the further these cracks are apart, the deeper the failure. Repair should be made at these areas to maintain the pavement system. Sealcoating and striping has been maintained. Areas of alligating, deterioration and depressions should be cut back removed to sub-base, testing and any unsuitable material removed, compacted and repaved. Cracks over 1/4" should be sealed with an elastomeric sealant before the next sealcoating cycle (generally every 2-3 years depending on wear).

**Parking lot pavement alligating**

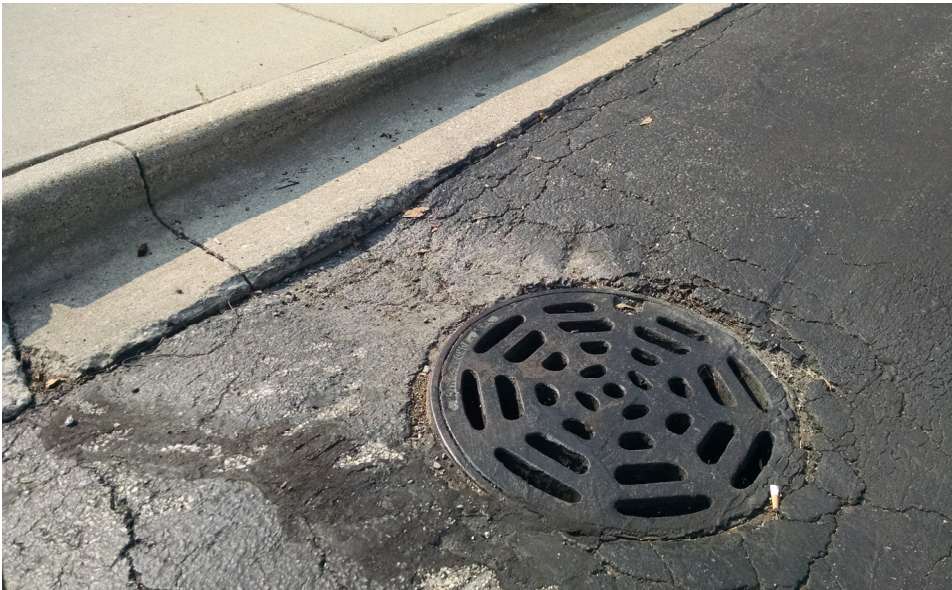
**Pavement subgrade failure near catch basin**

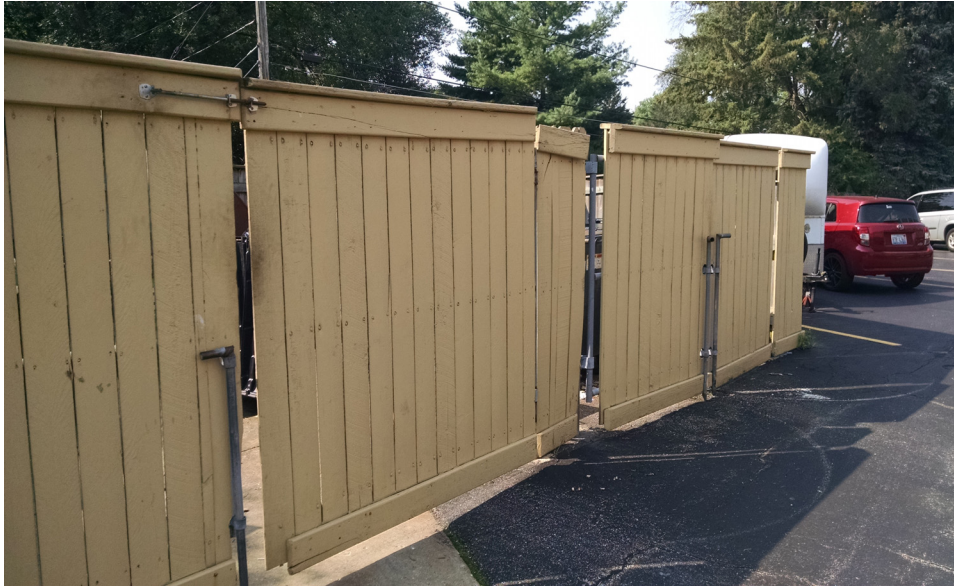
**Wood Fence at trash enclosure**

Dumpsters are enclosed behind gates and a wood fence at the southeast corner of the property. The overall size and maneuverability within the enclosure appears to be adequate. As the bituminous pavement ages and pavement repairs are made, it is recommended that the area within the enclosure and approximately 8 to 10 feet north of the enclosure be replaced with 8" thick concrete in lieu of bituminous pavement to improve durability against heavy garbage truck wheels and depressions made over time from trash container wheels.

Repair work needed at trash enclosure
10	Building minimizes "blind spots" that are difficult to monitor and secure	C		General layout of building creates complex geometry that may be difficult to monitor from street

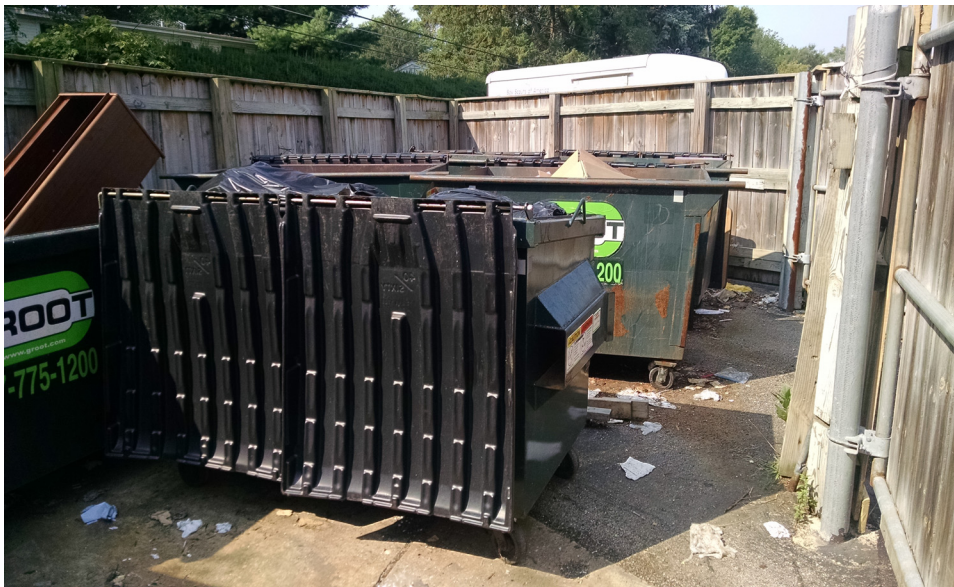
**Interior of trash enclosure**

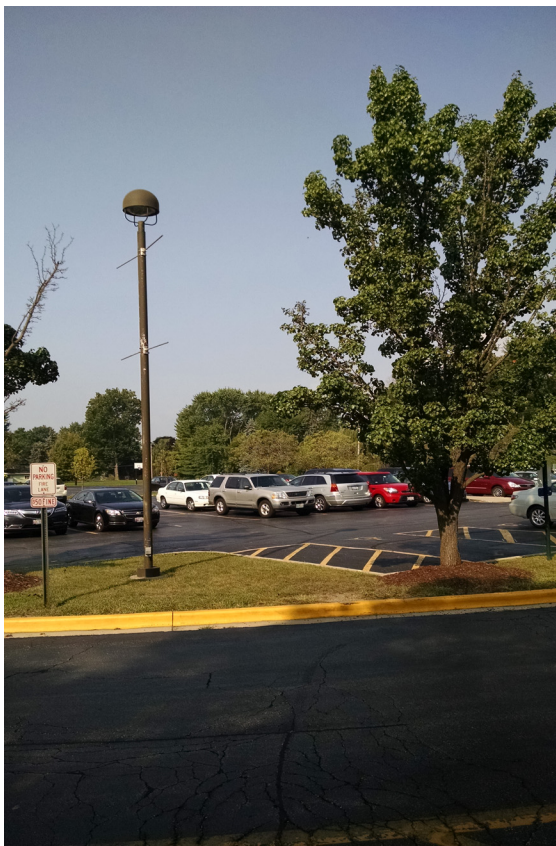
The exterior lighting consists of bollards located along the pedestrian walkways leading to the church facility, along with wall packs on the exterior walls of the 2-story school building and pole mounted floodlights to provide general illumination at parking areas. There is a roof mounted floodlight on the 2-story school building aimed toward the parking lot for additional supplemental lighting. All lights appear to be in working condition. Exterior lights contain HID lamps controlled by time clocks.

The main parking area west of the building appears to be have deficient nighttime light levels, especially near the far western edge closest to the stormwater detention area. Adding additional pole mounted fixtures is recommended to improve safety and security. New light poles should be LED source for energy efficiency, reduced maintenance, and light distribution pattern. Considerations should also be made to replace existing exterior lighting with LEDs for consistency of light color, lumens and the reasons noted above.

**Typical Light Pole**

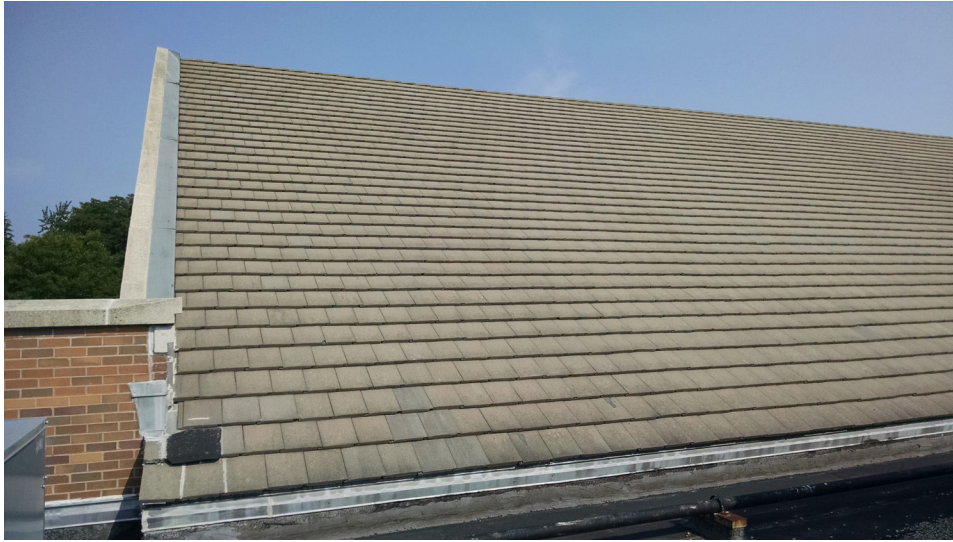
The central gable roof over the worship space and portions above the narthex are a concrete tile product original to the building. Concrete roof tiles often last 35-40 years or more. Concrete tiles are Class A fire rated and resistant to damage from hail and high winds, typically achieving a minimum of a Class 3 hail resistance rating. Some concrete tile roof systems can sustain winds in excess of 125 miles per hour which would cause damage to many other roofing materials. A yearly visual inspection of a concrete roof can help protect against accumulation of leaf debris and moss growth. Moss and algae do not harm concrete tiles, but periodic cleaning with a power washer by a professional can remove them, and the use of biocides or zinc strips may be incorporated to slow the growth of these organisms. After periods of high winds or hail, a visual inspection of the roof should be made to ensure that there are no cracked, broken, or loose tiles needing replacement. Concrete tile roofs are prone to moisture penetration from wind driven rain or snow more than any other type of roofing product. The underlayment, batten system, and flashing and quality of installation are very important and key to determining how long the roof will last. In this installation, the tile have lost some surface texture over the years, but with continued maintenance should last another 10-15 years.

**Concrete Roof Tiles at Nave**

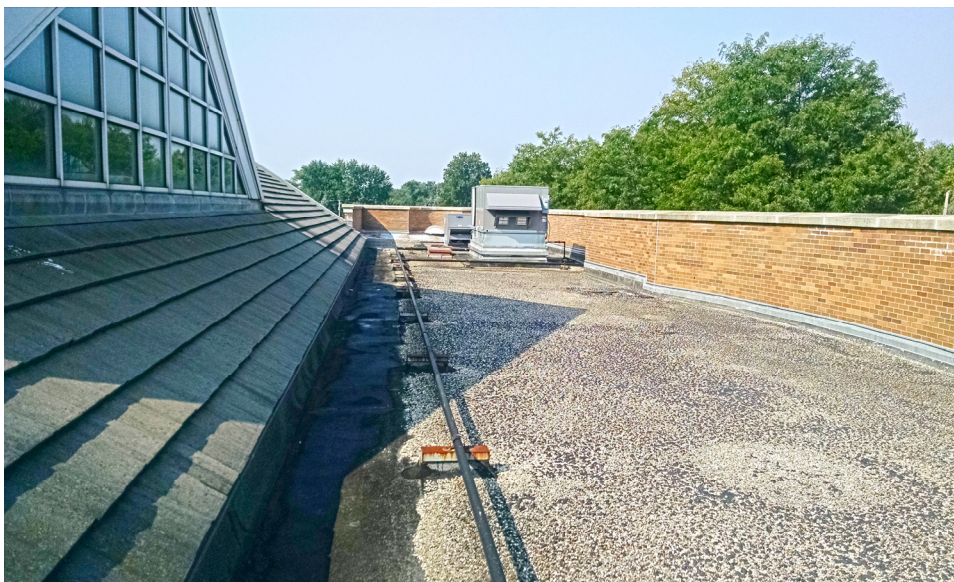
The low sloped loped modified bitumen roof system installed over the central portion of the narthex, day chapel and perimeter ancillary support spaces is original to the building. Modified bitumen roof systems often last 20-25 years. Long term exposure of the bituminous material to ultraviolet rays eventually degrade the roofing system causing blisters, split seams, and separation from walls and flashings. Signs of deterioration are evident at flashing and boot penetrations at vents, exhaust fans and pipe supports. This roof system is at the end of its expected life and should be budgeted within the next two years for complete replacement. Regular inspection and maintenance is recommended to address areas of deterioration and ponding.

**Low Slope Modified Bitumen Roof South of Nave**

Both the pitched roof and low slope modified bitumen roof systems slope to internal roof drains connected to the storm sewer system. Roof drains should be cleaned and inspected for proper operation quarterly.

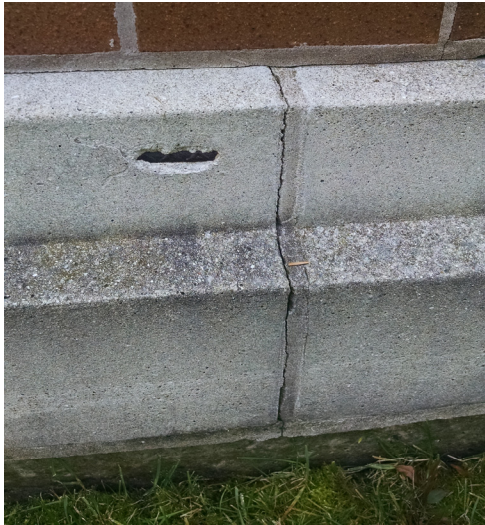
Limited re-pointing work is needed at and around lintels at several window openings and at the water table course.

**Water Table Tuckpointing**

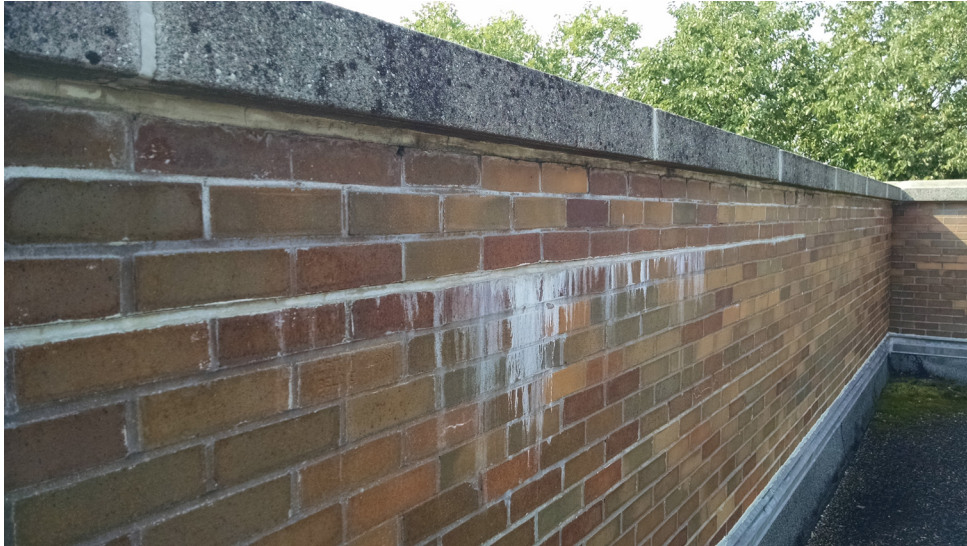
Masonry parapets with concrete caps above the low slope roof areas show evidence of water infiltration with missing or deteriorating flashing at the coping which is the likely cause of efflorescence and hairline cracking visible at the backside of parapet areas. As part of a re-roofing project, the parapet coping should be removed and re-flashed or wrapped with pre-finished metal to eliminate further water penetration into the cavity wall system.

**Efflorescence at Parapet Cap**

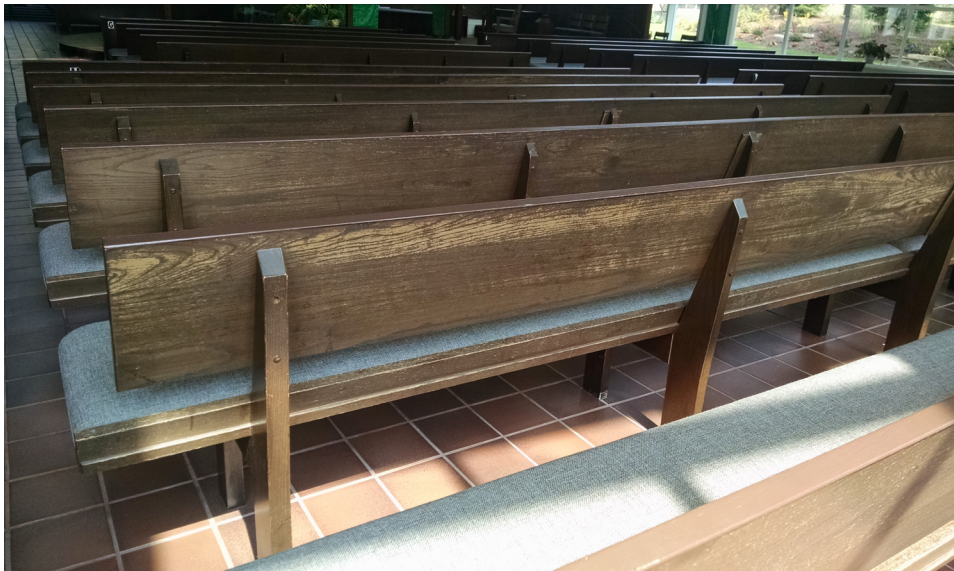
The wood pews are generally in good condition, though pews along the southern window exposure will need refinishing within the next 2-5 years. In addition to exposure from the sun, the top edge of backrests begin to show signs of wear, generally after 10-15 years of use. The cushioned seats do provide protection of the seat platform. If pews along the south wall are addressed in the next few years, it is anticipated the remainder of pews will need refinishing within the next 10 years.

Wood Pews

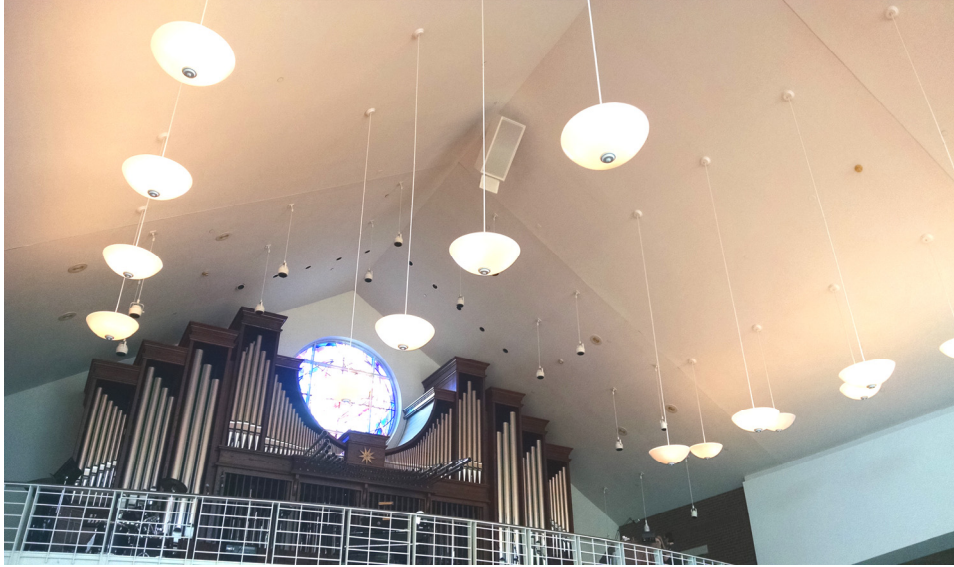
spaces. T12 fixtures are recommended to be replaced with more energy efficient bulbs. Overall, the light levels appear to be adequate throughout the building.

**Nave Lighting**

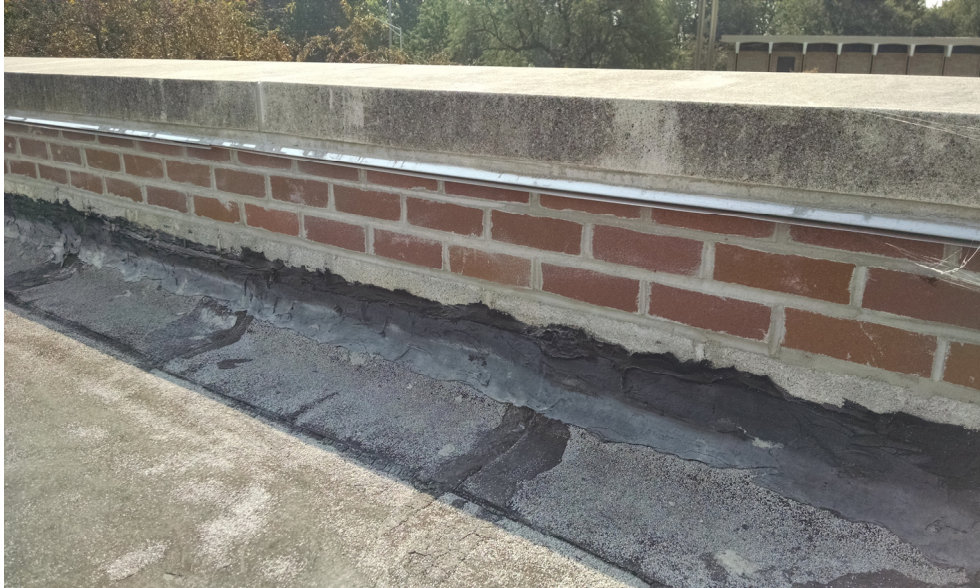
The low slope modified bitumen roof system is generally in fair condition with signs of patching, only minor areas of ponding, and seam deterioration consistent with the age of the roofing. This type of roof system has a life expectancy of 15-20 years. Masonry parapets with concrete caps above a majority of the low slope roof areas received recent work. Flashings appear to be repaired to minimize or eliminate further water penetration into the cavity wall system below. Additional flashing work is needed to prevent water infiltration through exposed CMU at the backside of the parapet at upper roof areas.

**Exposed CMU at upper roof area**

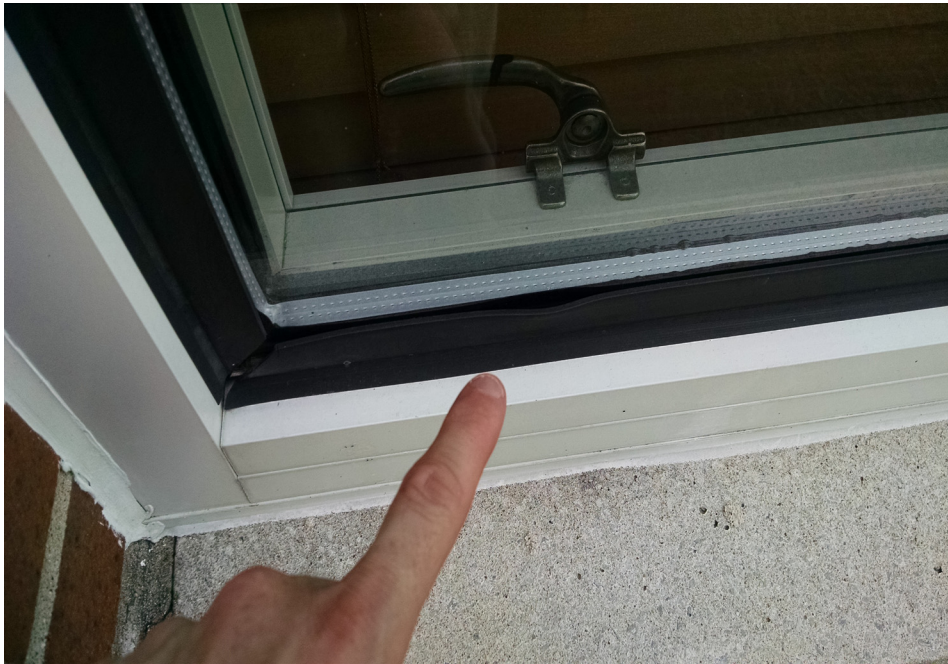
Exterior windows are a combination of fixed and operable Kawneer pre-finished aluminum windows with 1" insulated glazing. Observations made at glazing seals include shrinking gaskets which should be further evaluated by a manufacturer's representative for repair or replacement.

**Shrinking / deformed perimeter gaskets**

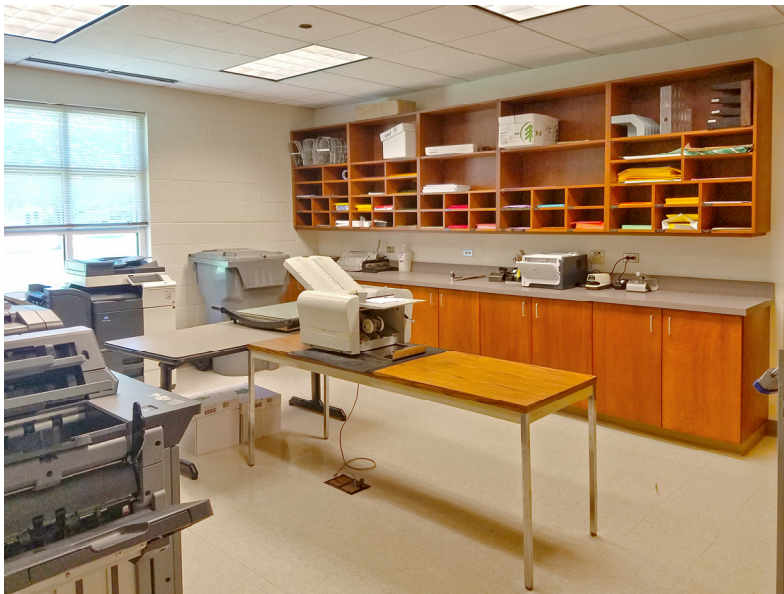
Built-in casework within offices and meeting rooms is wood veneer with plastic laminate tops. Casework is attractive and in good condition. We do recommend making minor modifications to the interior of the base cabinets in the mail room and the copy room to maximize storage capacity. This may include adding additional adjustable shelves or pull-out drawers to make reach easier.

Consider additional shelves or pull-out drawers to improve storage capacity

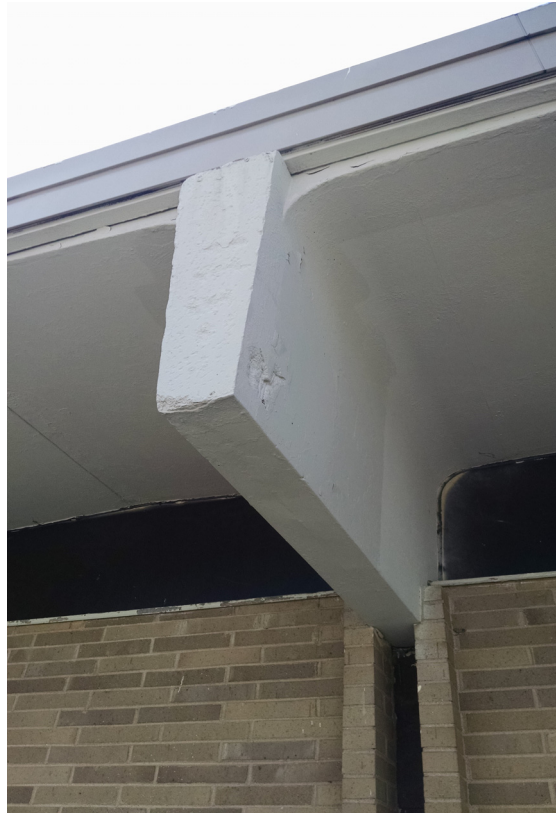
The pre-cast concrete tees are another challenge. The exposed edge of the tee makes the structure vulnerable to water infiltration and the damage caused by winter freeze-thaw cycles. It is evident many tees have been repaired over the years. This will continue to be a periodic maintenance project requiring regular inspections to ensure the safety of everyone below. Short term solutions may be to continue repairing the ends (use an epoxy-based grout). Longer term solutions might include fabricating and installing pre-finished metal caps at the ends of tees or enclosing the exposed structure with a soffit. At the gymnasium, enclosure would pose an additional challenge with the clerestory windows that occur along the top portion of the wall between tees. The windows themselves though, are also an energy-savings concern and a comprehensive solution may need to be considered for the best outcome – in terms of performance and aesthetic appeal.

**Pre-cast concrete roof members**

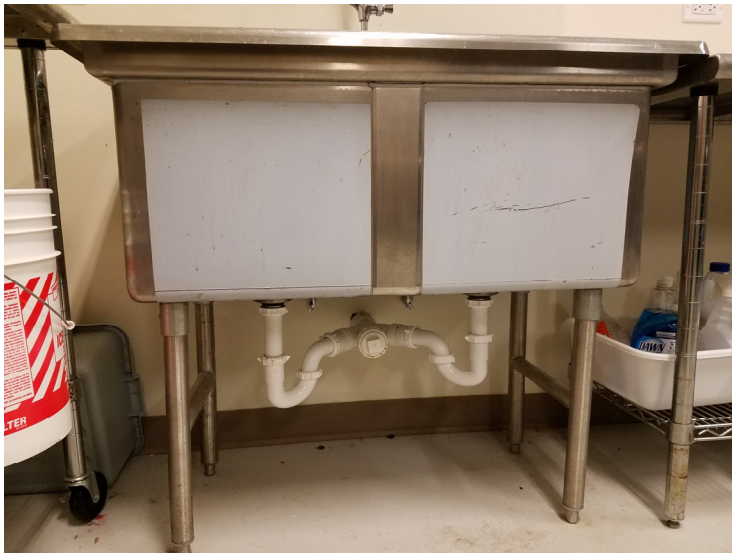
The Lower Level warming kitchen is equipped with stainless steel commercial fixtures. An existing double bowl prep sink is directly connected to sanitary waste. As a food and beverage handling area, the sanitary piping should be modified to provide an indirect waste discharge consisting of an open site drain and air-gap to comply with Illinois Plumbing Code Section 890.1010a. The open site drain and air-gap ensure that sanitary waste never makes its way back to the prep bowl of the sink should there be a clog or backup in the sanitary system.

**Warming Kitchen - Direct sanitary connection at double bowl sink**

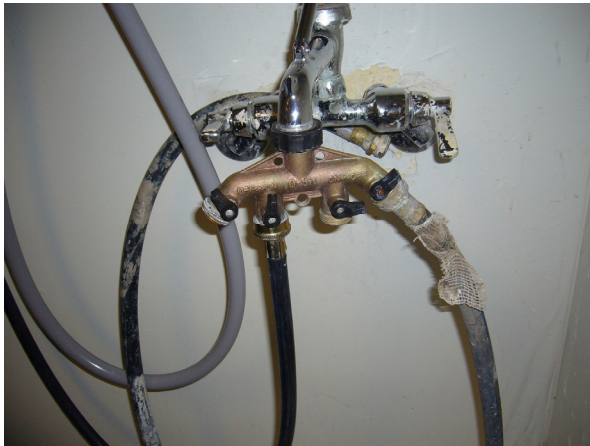
The Janitor's closet near the School Office has service sink with a soap system and water splitter device attached to the faucet. A proper backflow prevention device is recommended at this location. Though the faucet has a vacuum breaker, Illinois Plumbing Code does not recognize these devices as being adequate for direct connection to a chemical soap mixer. A backflow prevention device at the faucet in compliance with Illinois Plumbing Code Section 890.1130 will protect against accidental contamination of the water source within the building.

**Splitter at utility sink**

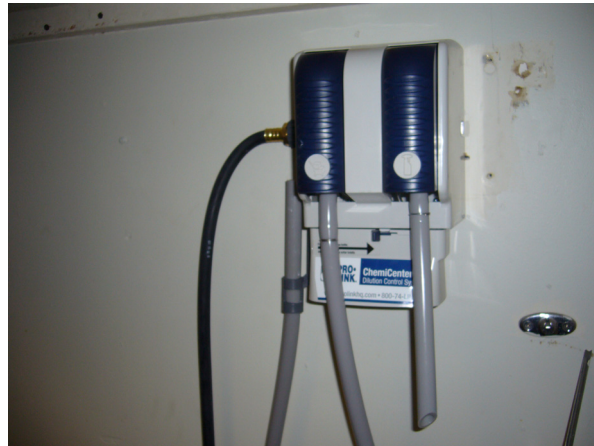
**Soap system at utility sink**
