# Physical Facilities Assessment

St. Raphael Parish  
1215 Modaff Road  
Naperville, Illinois 60540

Healy | Bender Project No.: 8-415-81

May 4, 2016

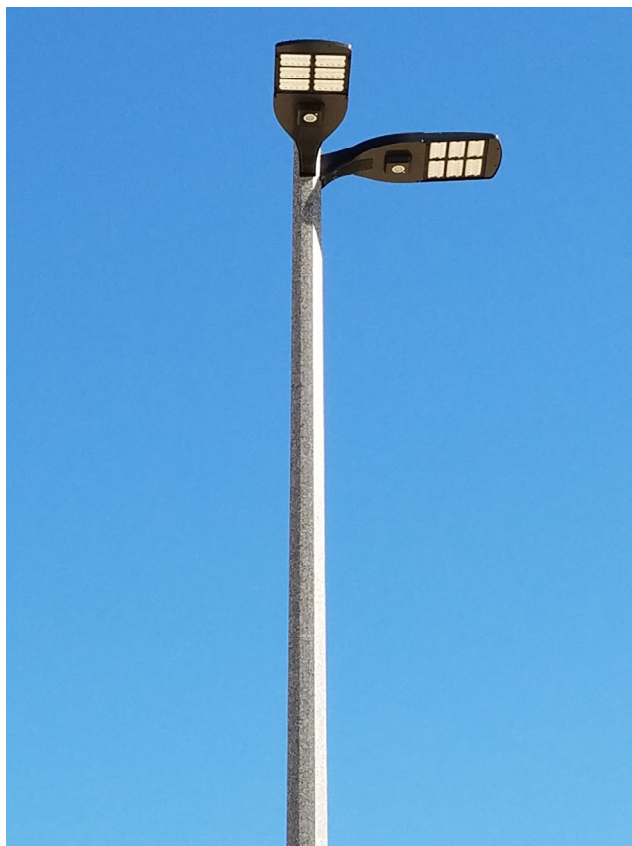
The main parking area west of the building appears to be have deficient nighttime light levels, especially near the far western edge closest to the stormwater detention area. Adding additional pole mounted fixtures is recommended to improve safety and security. New light poles should be LED source for energy efficiency, reduced maintenance, and light distribution pattern. Considerations should also be made to replace existing exterior lighting with LEDs for consistency of light color, lumens and the reasons noted above.

**Example: Energy-efficient LED site lighting**

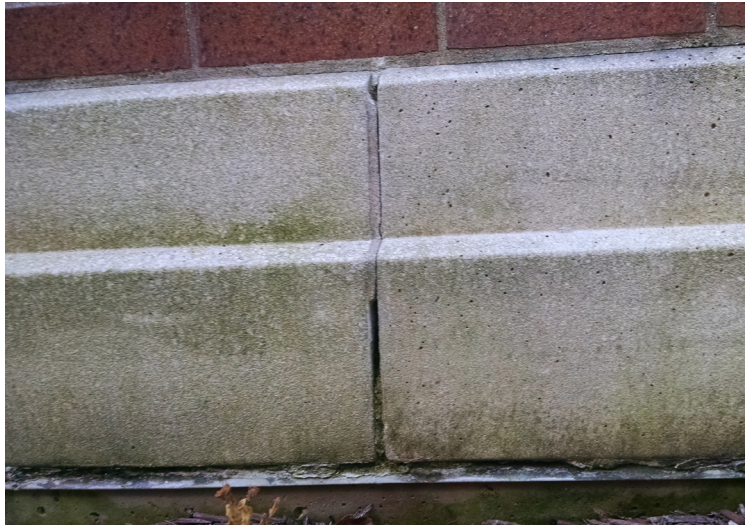
Masonry parapets with concrete caps above the low slope roof areas show evidence of water infiltration with missing or deteriorating flashing at the coping which is the likely cause of efflorescence and hairline cracking visible at the backside of parapet areas. As part of a re-roofing project, the parapet coping should be removed and re-flashed or wrapped with pre-finished metal to eliminate further water penetration into the cavity wall system.

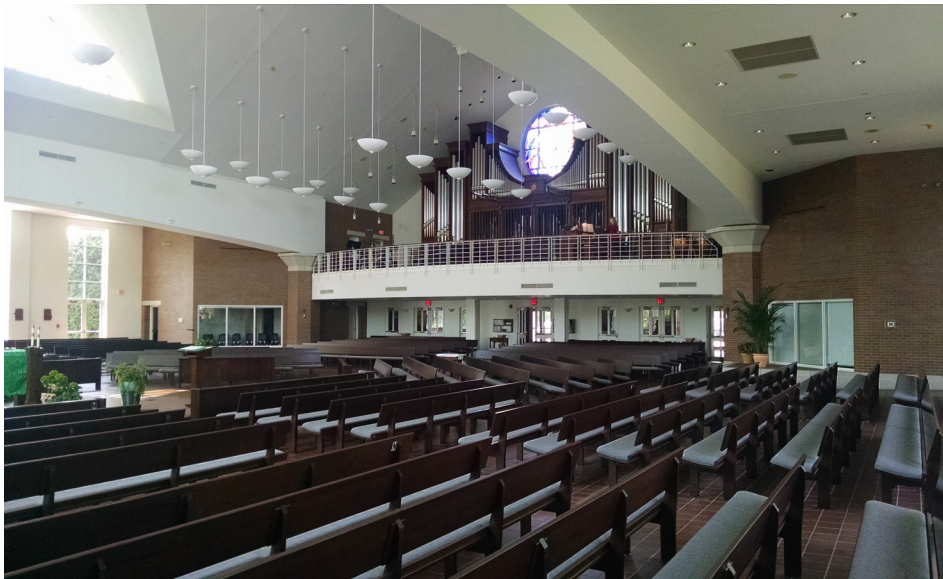
Generally, the interior finish materials are durable, and well suited for use in the worship environment. The condition of finishes is consistent with the age of this facility, and most have been well maintained. The general cleanliness and condition of the interior finishes indicates that maintenance is a priority.

Drywall throughout the building appears to be in good condition with no visible areas of stress cracks or deterioration.

**Typical finishes at church interior**

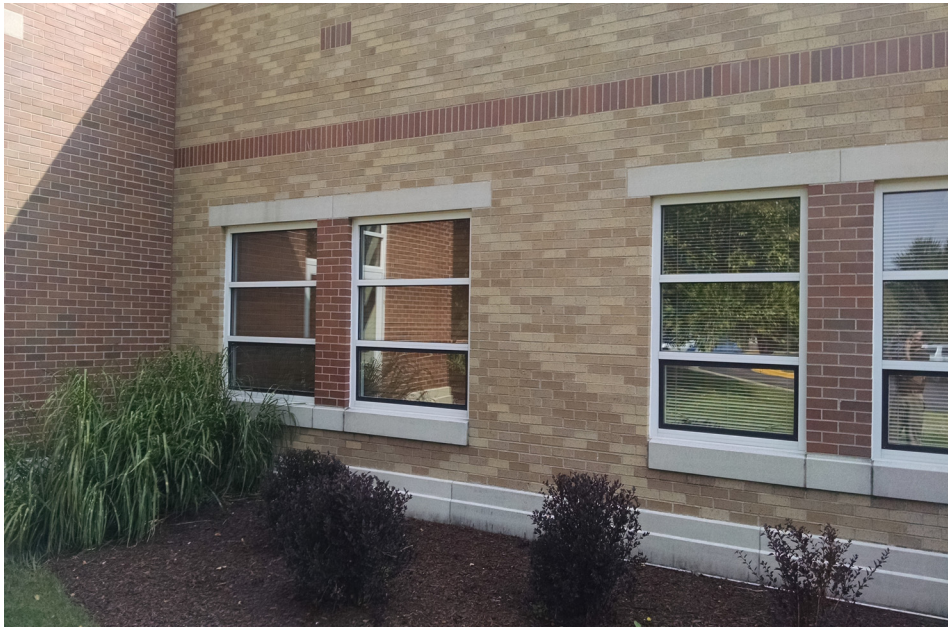
The parish office building is steel frame with face brick veneer over CMU backup on concrete foundations. Wall construction is a cavity wall system. A continuous stainless steel drip is in place at the bottom of the wall. Weeps and rope were generally visible at the damp course flashing (bottom of the wall) and above openings. Face brick is generally in good condition without signs of spalling or excessive moisture absorption. Mortar joints are in good repair, with less than a hundred square feet total needing re-pointing. Areas of discolored tuckpointing should be cleaned and monitored for further discoloration. All dissimilar materials abutting or penetrating the masonry walls should be properly sealed with a silicone-based or flexible building sealant including windows, mechanical and electrical piping.

**Typical exterior masonry and aluminum windows**

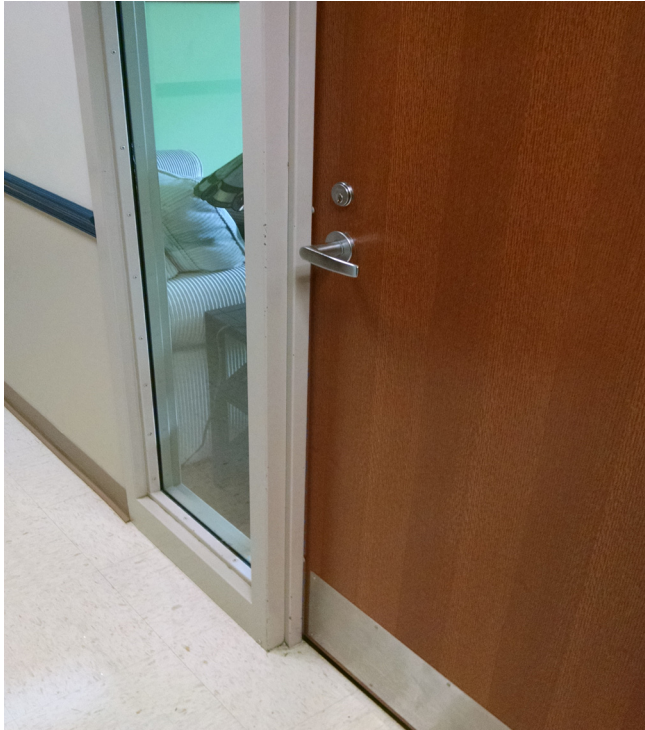
Interior doors at the office are a combination of solid wood doors with and without glazing in hollow metal frames. Doors are stained and frames are painted. All appear to be in good working condition. Primary egress doors are equipped with panic hardware. Doors to ancillary and support spaces are equipped with ADA compliant lever handles. Other hardware such as hinges and door closers appear to be heavy-duty and are in good working condition. With continued maintenance, interior doors and hardware are expected to last at least another 30-40 years.

**Typical interior door and hardware**

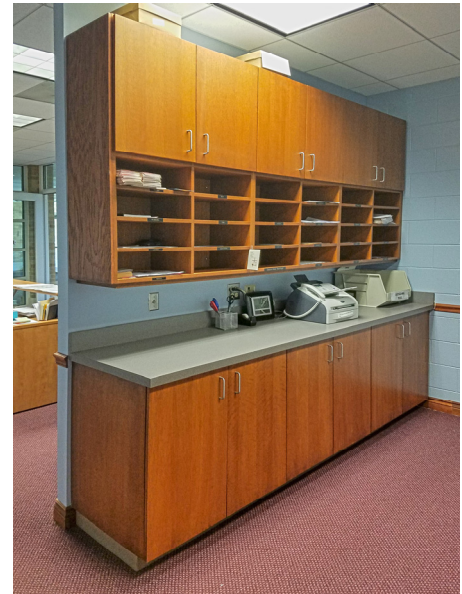
Consider additional shelves or pull-out drawers to improve storage capacity

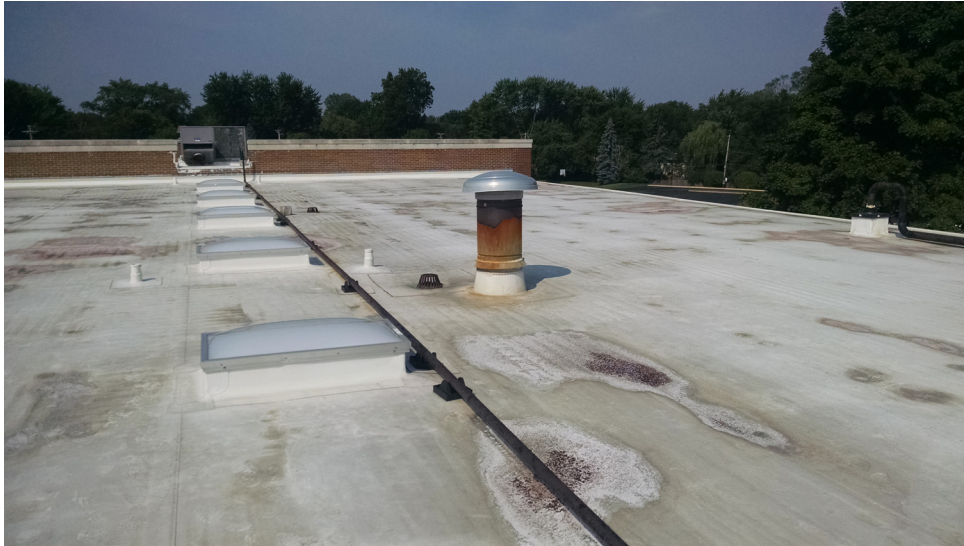
A white EPDM roof was installed on the original section of the school in 2012. The roof membrane, skylights, pipe supports and flashings and all other components of the roofing system appear to have been installed at the same time. The roof is in 'like new' condition and if properly maintained, is expected to last 20-25 years. We recommend regular inspections and maintenance on the new roof to prolong the life expectancy of the roof system.

**New Roof at Original Section of the School**
